**IOWA STATE PATROL
TECHNICAL COLLISION INVESTIGATION**

ISP Case 2013031880 TI FILE 13-056

SUBJECT: Three Vehicle Collision, Single Fatality

LOCATION: 156 mile marker westbound on Interstate 80, Jasper County, Iowa

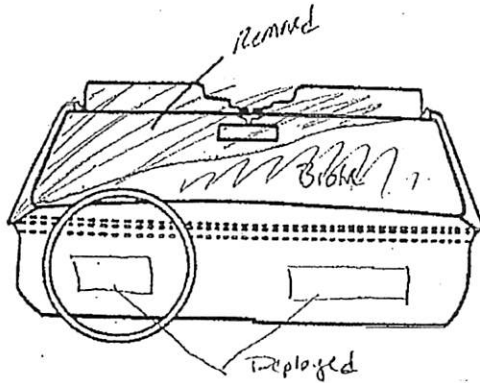
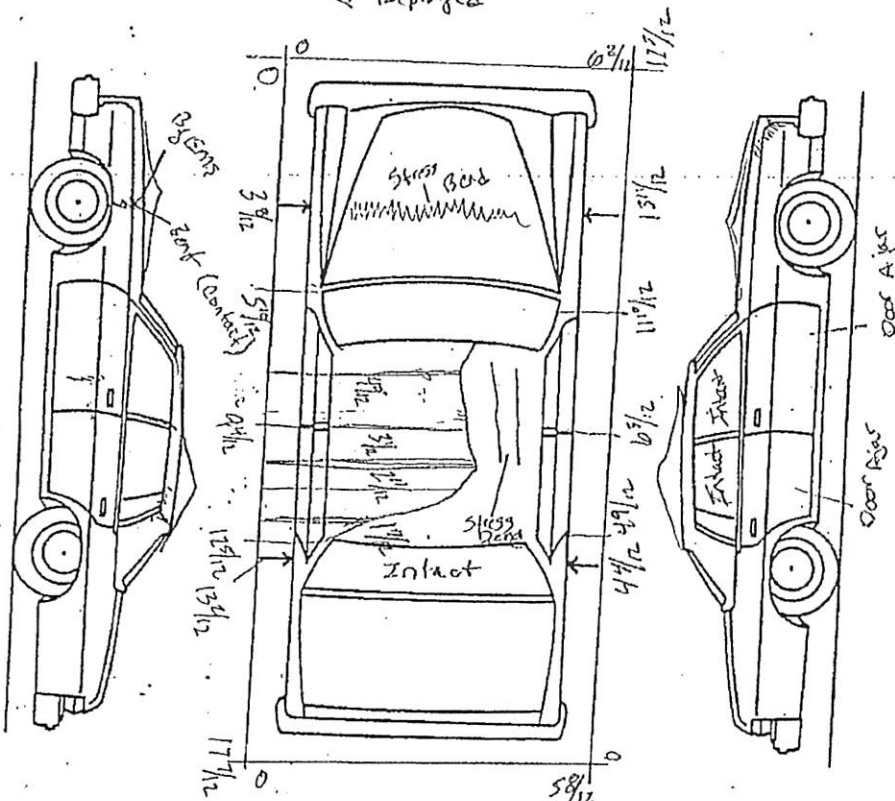
VEHICLE TYPE		
2000 Mercury 4D		
REGISTRATION	STATE	YEAR
CZ14134	TX	13
SERIAL NO.		
2MEFM74W19X1011717		
COLOR	ODOMETER	
White

* Both Airbags Deployed
* Tinted Windows

VEHICLE DAMAGE LEFT SIDE: The left side of the vehicle sustained a substantial amount of damage from the collision. The left front fender was bent in the front portion due to the fender colliding with the rear duals of the semi-trailer. The rear part of the front left fender had scrape marks and was also dented. The front left door was removed from the emergency crew; however, the door had contact and stress damage. The A pillar was bent downward from the collision. The B pillar was removed from the emergency crew; however, it had damage also from the collision. The rear left door was pushed and bent backward from the collision. The rear door also had contact and stress damage from the collision. The rear left fender had a stress dent by the gas tank door. The C pillar was twisted from the collision and was also bent downward into the cab. The left side mirror was broken and removed from the collision. The left side windows were all broken out from the collision. The front left tire was flattened from impact; however, the rear left side tire was upright after impact, but the emergency crew had to flatten it to get the car out from underneath the semi (vehicle #3).

VEHICLE DAMAGE RIGHT SIDE: The right side sustained damage from the collision. The front right fender was damaged from the collision with vehicle #2. The front right fender was twisted with some paint damage. The front right side door was out of alignment and ajar. The A pillar was bent downward into the interior. The B pillar was bent downward towards the interior also. The rear right side door was ajar and out of alignment. The rear right fender was not damaged. The right side mirror was still intact and functional. The right side windows were still intact. The right side tires were still inflated after the collision, however, the emergency crew had to flatten them to get the vehicle out from underneath the semi-trailer (vehicle #3).

VEHICLE DAMAGE FRONT END: The front end of the vehicle had sustained damage. The front right side of the bumper was detached from the first collision. The front grill and cover was broken and removed from the first collision. The hood was bent back and upward from a front end collision. The left front side of the vehicle was damaged from the collision with the rear back duals of the semi-trailer (vehicle #3). Both headlight assemblies were broken out and removed from the collisions. The windshield was cracked and also some of it was removed.

VEHICLE DAMAGE TOP: The top of the vehicle did sustain a substantial amount of damage. The top of the vehicle was bent upward from the collision with the semi-trailer (vehicle #3). The A pillar and B pillar on the left side was removed from the top of the vehicle. The damage was contact and stress damage.

MISCELLANEOUS INFORMATION: Due to the amount of damage to the left side of the vehicle, It is undetermined if the driver was utilizing his safety belt. Both airbags were deployed, unknowingly if they deployed at first impact or at secondary.

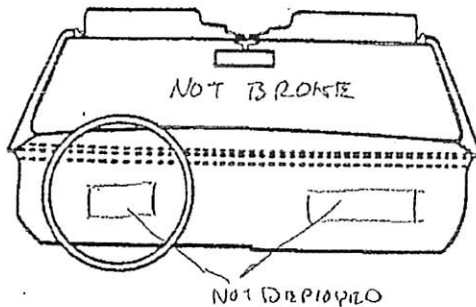
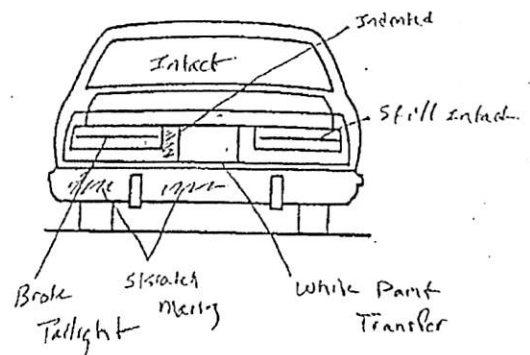
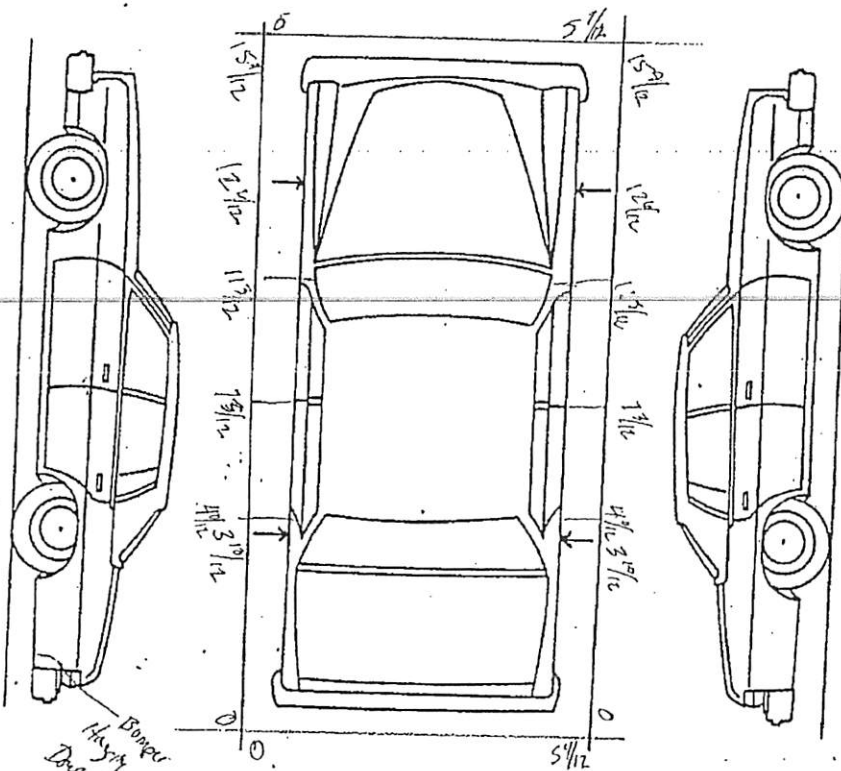
* Airbags Did not Deploy

* All windows are Intact / NOT BROKE

VEHICLE DAMAGE REAR END: The rear of the vehicle had substantial damage from the first collision. The right side of the rear end had scrape marks. The left side of the rear end had the most damage from the first collision. The trunk lid was caved in from the impact. The left side of the bumper contained scrapes from vehicle #1. There were scrapes also underneath the rear end bumper, showing that vehicle #1 under-road vehicle #2 when the collision occurred. On the rear bumper there was white paint transfer from vehicle #1.

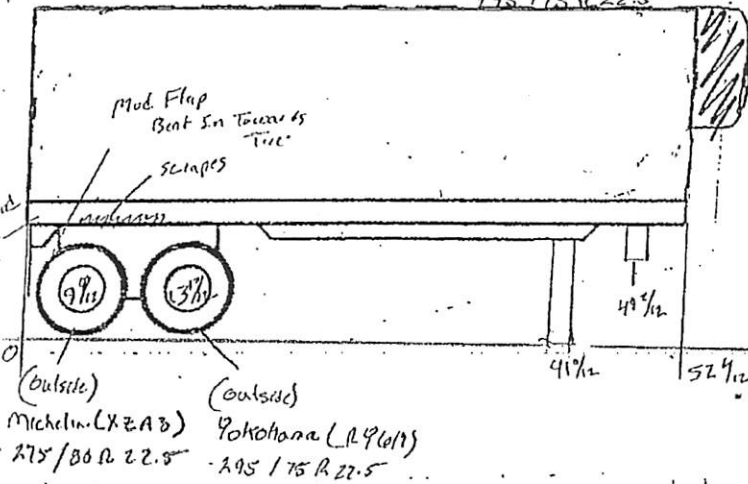
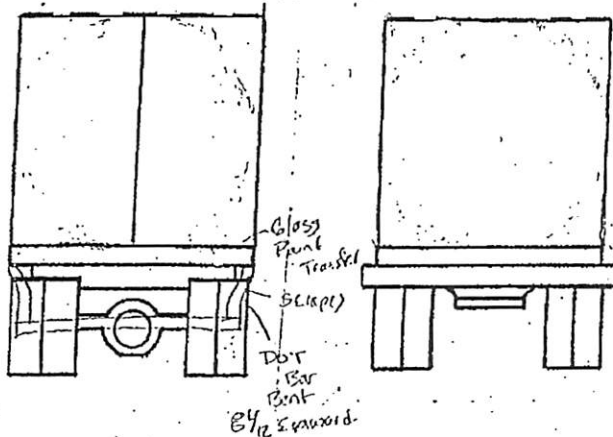
VEHICLE TYPE		
2005 WANC (Trailer)		
REGISTRATION	STATE	YEAR
PP 5896	MO	13
SERIAL NO.		
155 V532 LKX 5L 929605		
COLOR	ODOMETER	
White

Misc. Rear Front Right Brake Line Hose
was disconnected before collision occurred.
& Reason why on the shoulder

VEHICLE #3 (TRAILER) DAMAGE REAR END: The rear of the trailer sustained most of the damage. The lower right rear (DOT) bumper or metal support was bent inward from the collision. On the right side, by the light assembly, and bumper there was a piece of windshield that was still connected to the bumper from vehicle #1. On the rubber bumper stop there was a piece of white paint from vehicle #1. The right side of the DOT bumper there was blood transfer from the fatal subject.

VEHICLE #3 (TRAILER) MISCELLANEOUS: Through a thorough investigation, I found that the brake line on the rear back duals of the trailer was cut before the collision occurred. I interviewed the mechanic that worked on the semi after the collision and asked him if the back brake (air) line was cut would it stop the vehicle. He advised that the vehicle wouldn't be able to move. The operator of the vehicle was outside the semi so there was no need for a safety belt to be utilized.
